STATE OF SAFETY REPORT 2015/16

10-YEAR ANNIVERSARY EDITION

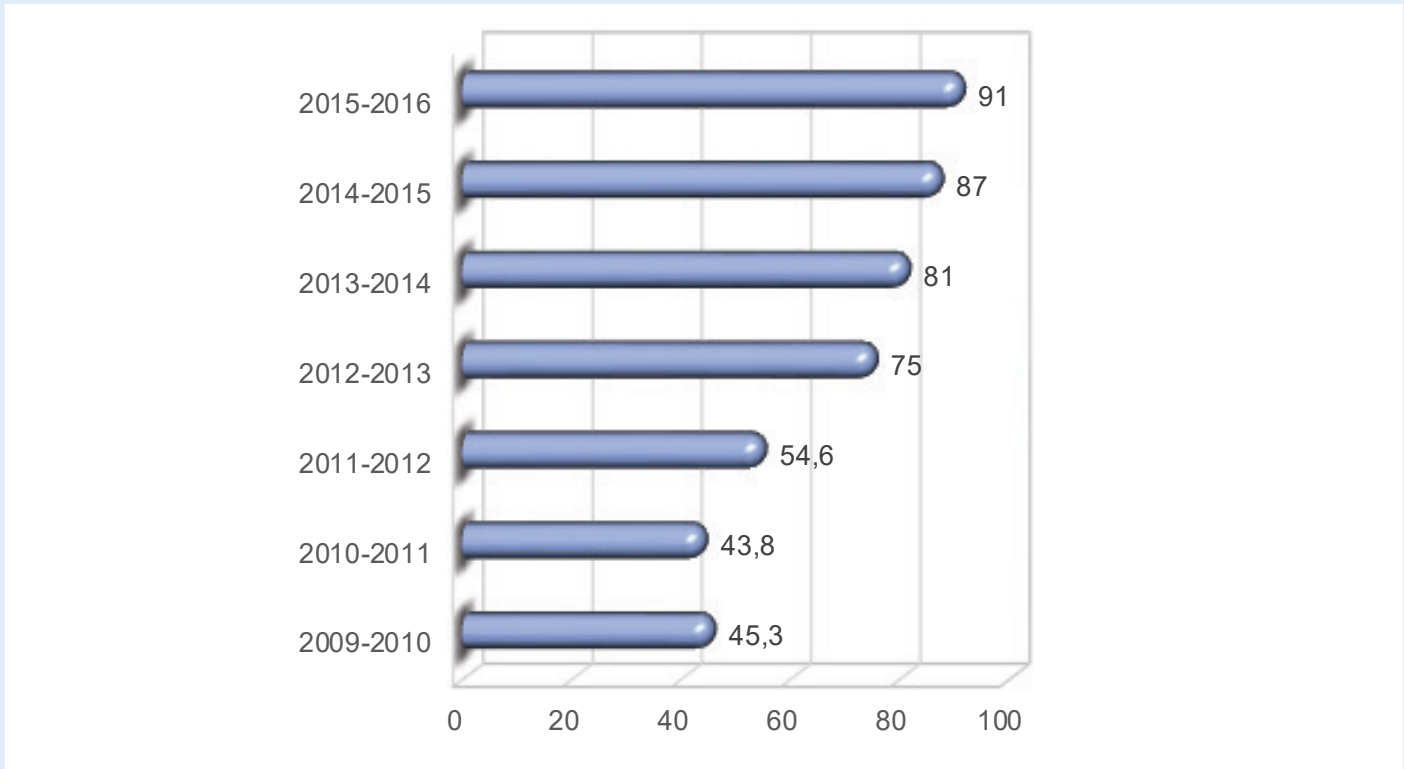
Figure 2: Occurrence reports submission percentage trend from 2009/10 to 2015/16

During 2015/16, an average of 91% of operators complied with the reporting requirements as per the Act. The noted increase in compliance to requests for submissions since the 2011/12 reporting period may be influenced by the operators being more exposed to the RSR requirements and obligations presented to them through the RSR Technical Workshops pertaining to regulations and standards. The annual average submission percentage data may be presented below:

The submission of quarterly reports to the RSR by railway operators issued with safety permits forms part of the conditions of the operators’ railway safety permits. Operators who failed to comply are liable for any corrective action the RSR deems appropriate to encourage compliance. The RSR is thus mandated to issue non-compliance directives or penalties in accordance with the RSR Penalty Regulations 2011, as amended, as provided for in the Act in order to achieve a 100% submission rate.

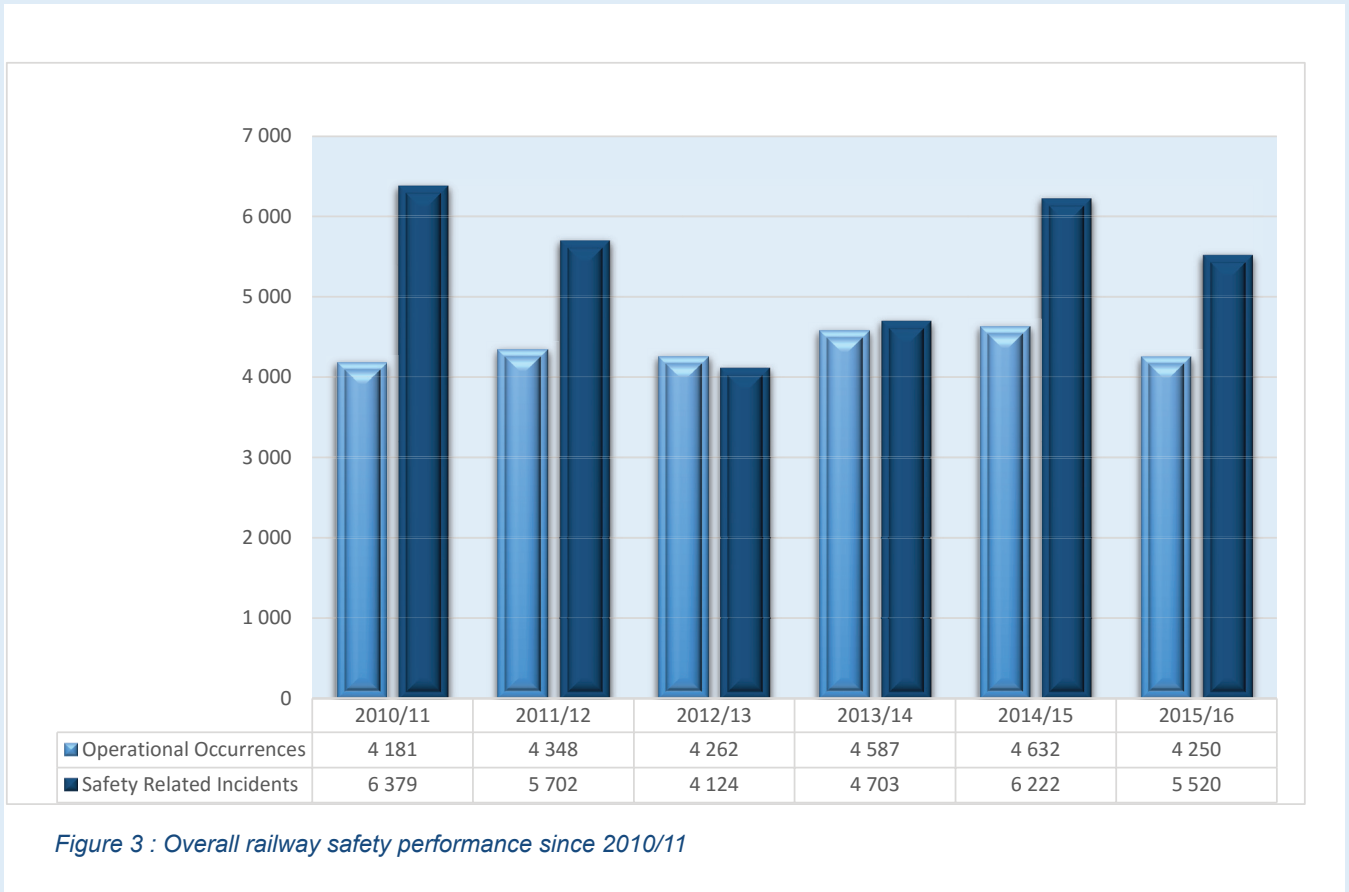
decrease in operational occurrences and safety-related incidents. The total number of 4 250 operational occurrences in comparison with 4 632 in the previous reporting period indicates an 8% decrease. The 5 520 security-related incidents recorded indicates an 11% decrease from 6 222 incidents recorded during the 2014/15 reporting period. The graph illustrates the overall safety performance of the South African railway industry since 2010/11.

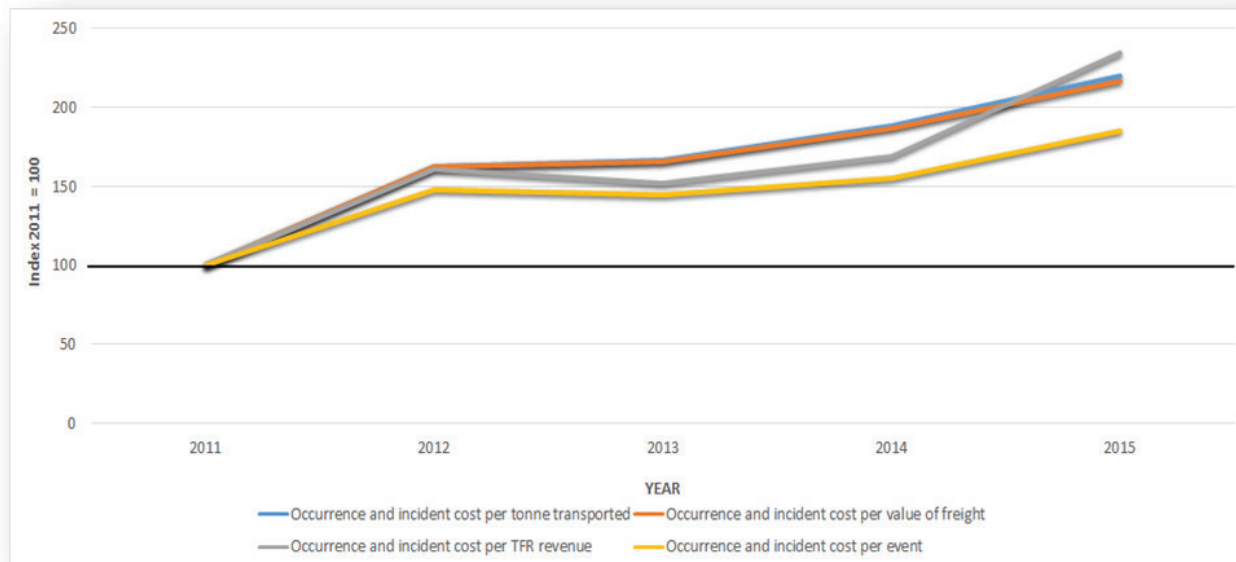
Figure 50 : Regulatory Impact Assessment (RIA) for freight rail from 2011 to 2015 (Index 2011 = 100)

Figure 50 shows the indexed regulatory impact for freight rail from 2011 to 2015. The 2010 year was removed as the magnitude of the costs associated with derailments in 2010 relative to the other years made comparative analysis nonsensical.

The occurrence and incident costs as a function of tonnes transported, value of freight and revenue have all steadily increased to more than double the levels of the 2011 base year. The average cost per occurrence or incident has also increased albeit at a slower rate, relative to the other indicators.
